# Manhole Inspection Summary

Manhole # S37S\_\_020MH

**Inspection** ☐ Is Incomplete Rating: **3) Fair**

**Location** Address: **1228 williams rear**

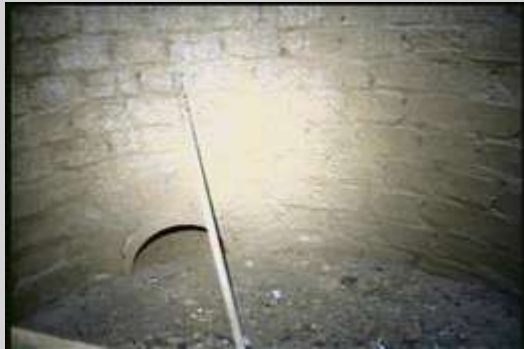
12 O'Clock Outflow

8 in. Circular Gravity Sewer  
Pipe Out @ 12 O'Clock

Deposits: ☐ None ☐ Mud ☒ **Sludge** ☐ Debris ☐ Grease

Silt Depth: **6** (in.) Deposits Extent: **Heavy**
